# **Preliminary Ecological Appraisal and Roost Assessment**

Premier Inn Llanelli Central East Hotel, Llandafen Rd, Lllanelli, SA14 9BD

Whitebread Group PLC.

18<sup>th</sup> July 2024

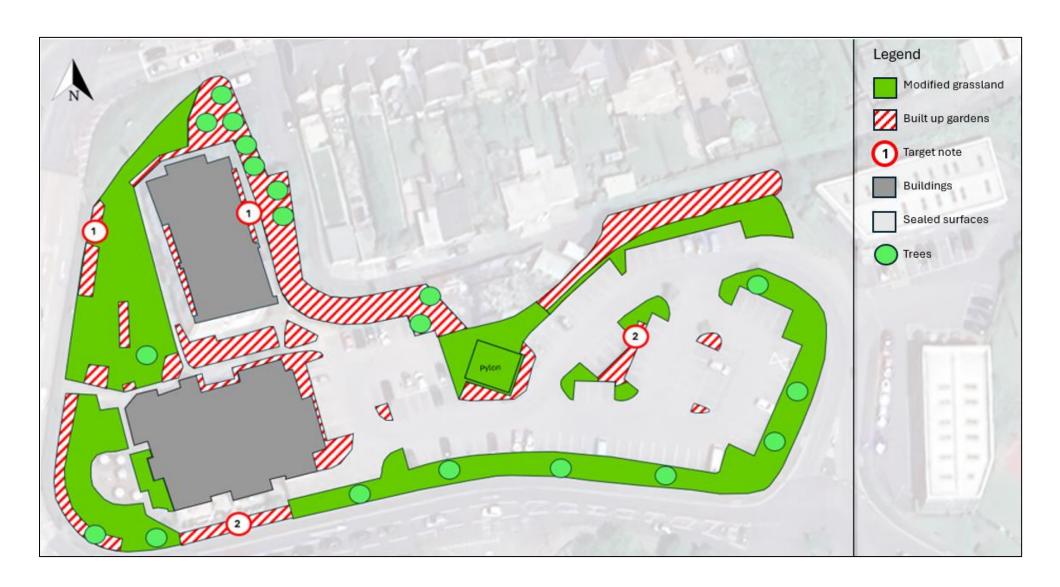
Appendix 2: Habitat drawing

The site comprises two commercial buildings, with associated carpark and landscaping across the site. These habitats (described below), and their corresponding UKHab codes, distribution and Target Notes (TN) are provided in the Habitat Drawing (Appendix 2). Corresponding photographs are provided in Appendix 5.

#### u1 – Built-up areas and gardens [introduced shrubs 847, scattered trees 32]

The areas surrounding the buildings, which form the active areas of the site, consists of hard standing pathways, patio areas and carpark, well managed amenity grass lawns (g4 modified grassland) and introduced shrubs which include and not limited to Guelder-rose (Viburnum opulus), Mexican orange blossom (Choisya ternate), Rock cotoneaster (Cotoneaster horizontalis), and Box-leaved Honeysuckle (Lonicera pileata).

There are numerous scattered trees across the managed area of the site include hornbeam, Italian alder and willow sp (Salix sp.) (see Plates 1 - 4).

u1b5 – Buildings [815 commercial building]		
	There were two commercial buildings on site. The Premier Inn (B1) and a former Beefeater restaurant (B2). Both		
	buildings are proposed to undergo renovation development and were therefore subject to a and Preliminary Roost		
	Assessment (PRA) (Refer to PRA in bat section below).		
	g4 - modified grassland		
	The amenity grassland lawns were identified across the site. The grass was recently mown and parched at the time of		
	the survey. The amenity grassland was dominated by perennial ryegrass (Lolium perenne) with occasional forbs		
	species such as Dandelion (Taraxacum sp.), Ribwort plantain (Plantago lanceolata) and Daisy (Bellis perennis) (see Plate

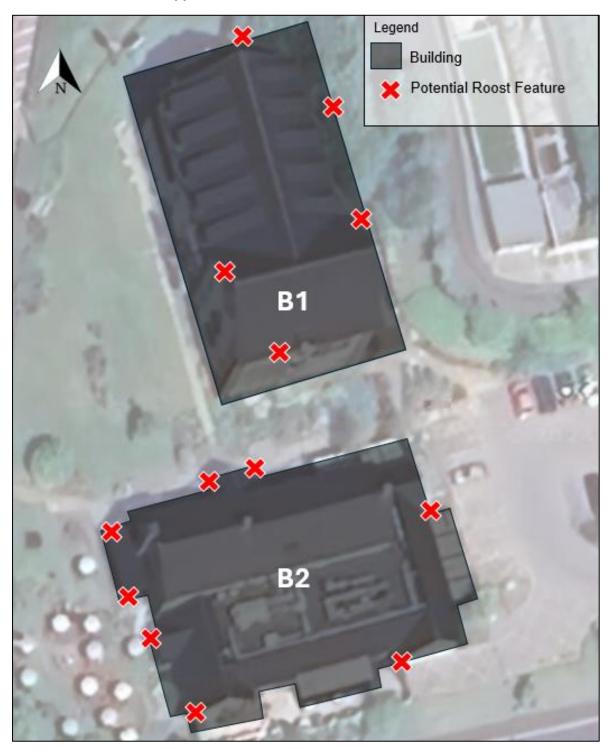
**Appendix 4 locations of Potential roost features**

No evidence of roosting bats was identified on the exterior of the building. However, several potential access points were identified (gaps, holes and crevices) via the soffit boards on the front, rear and sides of B1, which offer 'low' potential for roosting bats (refer to Appendix 4 and 5 for further information).

<b>B2</b> - The former Beefeater restaurant is a two-story building with a pitched roof, rendered external walls and wooden
	porch features.
	No evidence of roosting bats was identified on the exterior of the former Beefeater restaurant, However, several
	potential access points were identified via the soffit and between roof tiles and facia boards. Additionally, several
	panels were missing from the porch ceiling on the north west corner. These features offer 'low' potential for roosting
	bats (refer to Appendix 4 and 5 for further information).
	Roosting habitat – Trees
	There were no trees within the proposed site boundary that contained suitable features to support roosting bats.
Foreseen Impacts	Foraging and commuting habitat
	The proposed development will not result in the removal of any habitats which could be used by foraging or
	commuting bats.
	Roosting habitat [Buildings]
	<b>B1</b> – The external inspection of the Premier Inn identified 'low' potential for roosting bats.

<b>B2</b> – The external inspection of the former Beefeater restaurant identified 'low' potential for roosting bats.
	The external inspection from the ground of the roof identified multiple access points via the soffit boards which may offer roosting opportunities for bats. The proposals include a three-story annexe to the existing structure and will require modification to the roof space. If bats are present the works have the potential to cause disturbance, death
	or injury to bats.
	Roosting habitat – Trees
	None foreseen.
Recommendations	Roosting habitat [Buildings]

• One bat emergence/re-entry survey will be required on B1 and B2 during the active bat season (May – September)
	to confirm presence/likely-absence of bats roosting in or on the building. Survey visits should be completed during
	the optimal survey period mid-May to August inclusive.

• Sub-optimal: early May and September. Would require greater justification of timing e.g., weather conditions, known local bat activity.
	A minimum of four surveyors per building are required to provide full coverage of each of the building's elevations
	to look for emerging/re-entering bats.

• An infrared camera should also be employed as part of the survey to see where any specific roost locations are
	located.
	Lighting mitigation may be required based on the outcome of the night bat survey(s).
